SAUNA CRAFT HI LIMIT ADJUSTMENT AND REPLACEMENT

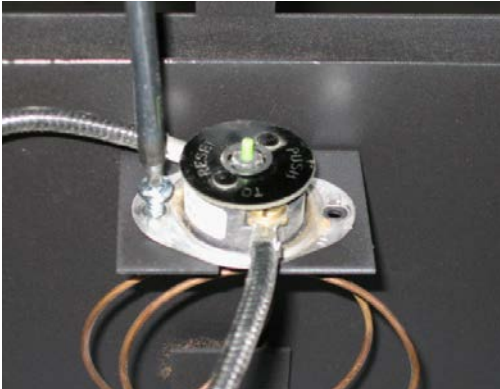
Unscrew Hi-Limit from frame

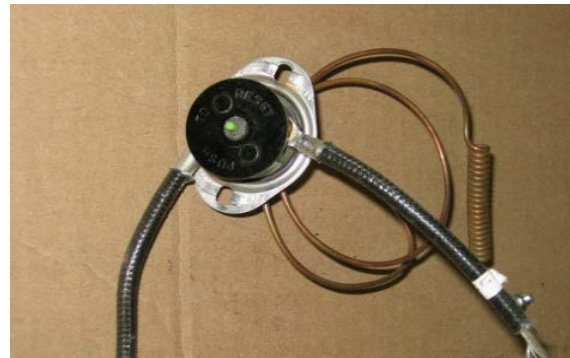
Remove lock washer and shield

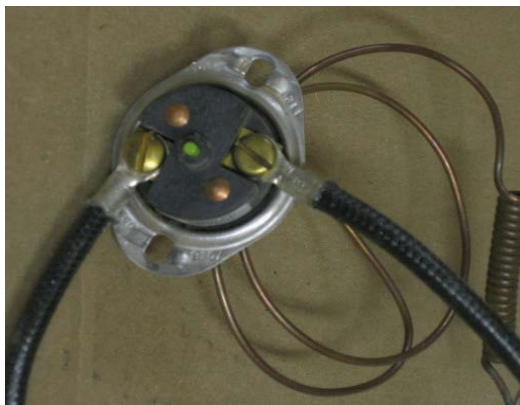
Remove wire leads. Replace hi-limit. Reconnect hi-limit.

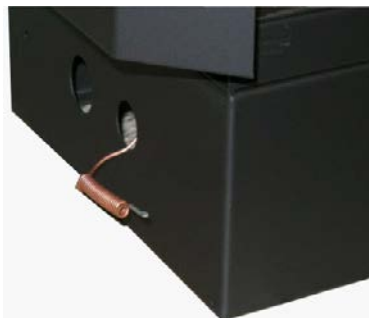
Re-install plastic shield and lock washer.

(A socket nut driver is useful to re-secure lock washer.)

Occasionally, hi-limits cause “nuisance tripping”. It may be caused by insufficient airflow or by retained heat in metal frame passing to the hi-limit. One way to address this is to place the hi-limit sensor through the back hole of the junction box and leave it suspended in air behind the heater.
